iRobot Roomba 860 Side Wheel Assembly Replacement

This guide provides instructions to remove the side wheel assembly if the iRobot Roomba 860 is unable to move or the wheels no longer spin

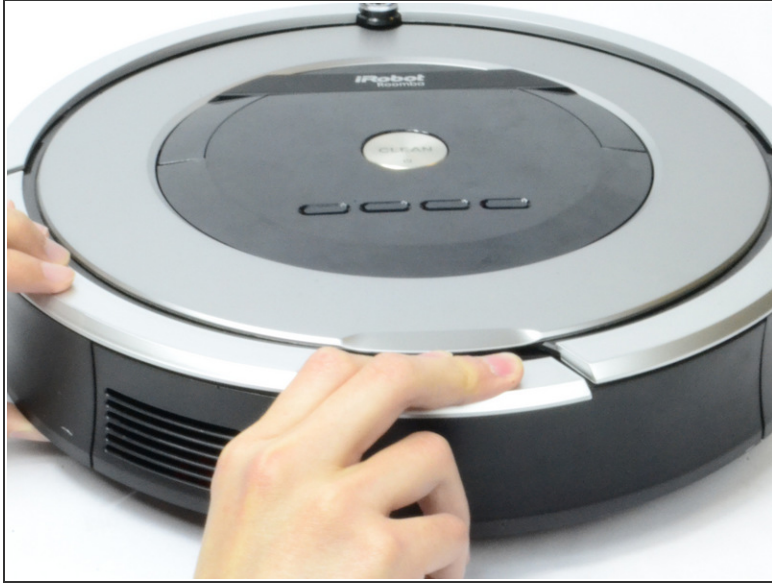
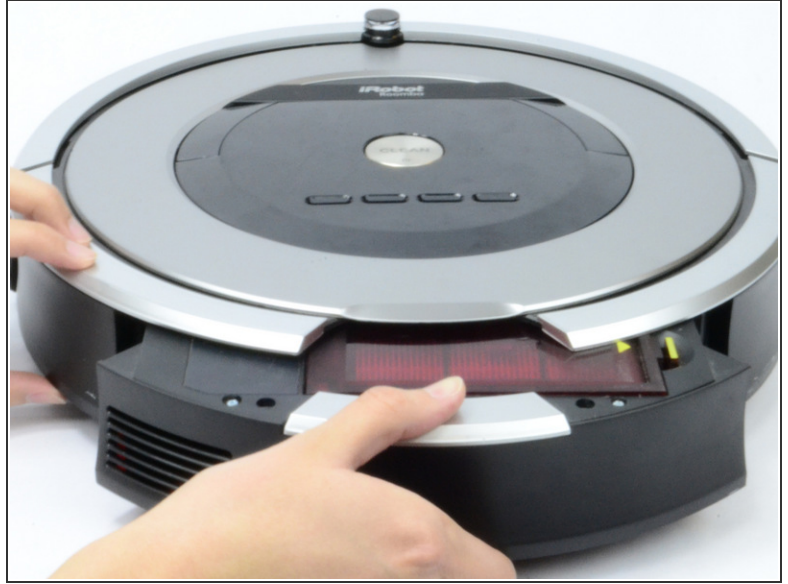
Step 1 — Debris Extractors

- To remove the debris extractor, first begin by removing and emptying the trash bin.
- Push down and pull out on the silver button located on the top of the Roomba in the back.
- The trash bin should then slide out.

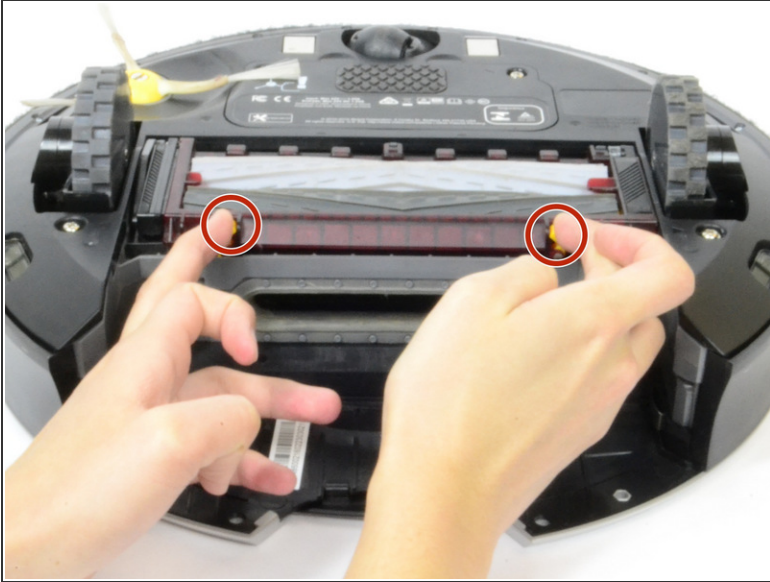
Step 2

- With the Roomba upside down, locate the two yellow buttons by the extractor.
- To open the flap holding the extractors in place, pinch the two yellow buttons together towards the center and pull up on the flap at the same time

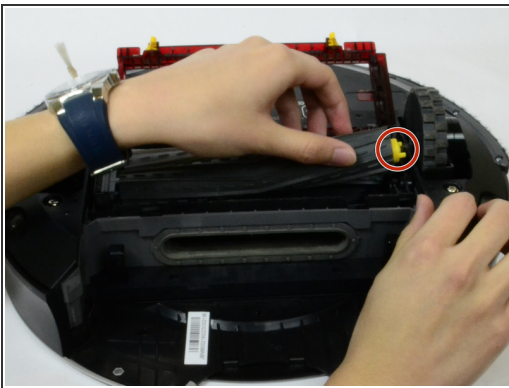
Step 3

- Once the flap is open, grab the yellow end of the dark gray extractor and pull up slightly.
- After lifting it up about an inch, pull it out towards one of the side wheels.
- The extractor should slide out with ease. Repeat the same procedure for the light gray debris extractor.
